Freedom Trail Mumbai  
August Kranti Maidan and it's Surrounds, D-Ward

**Heritage Conservation of August Kranti Maidan**

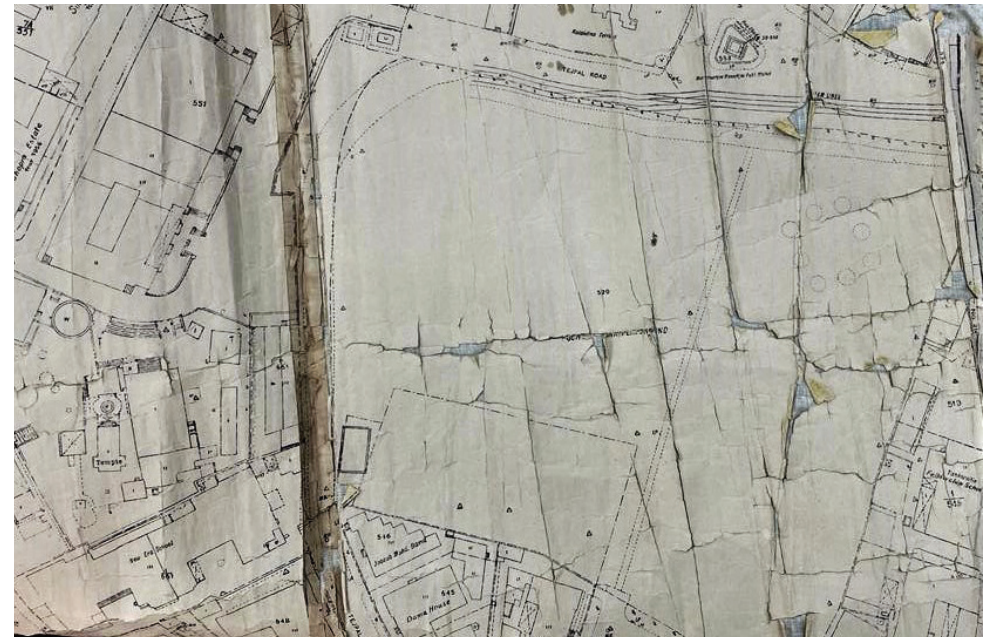
Maidan layout - 1960

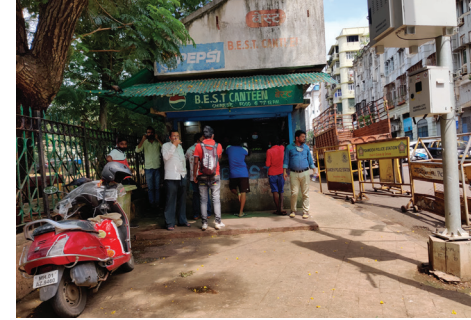
Existing structures on footpath - BEST canteen

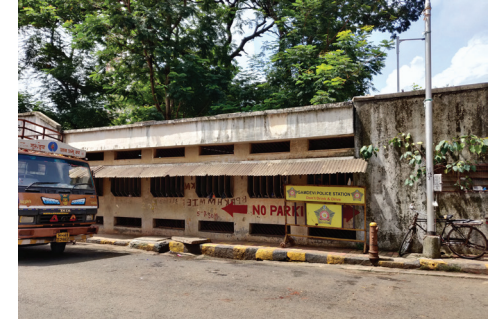
Existing structures on footpath – BEST canteen and shelter

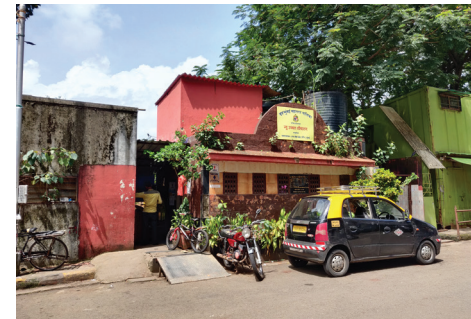
Existing structures on footpath - Sulabh Shauchalay

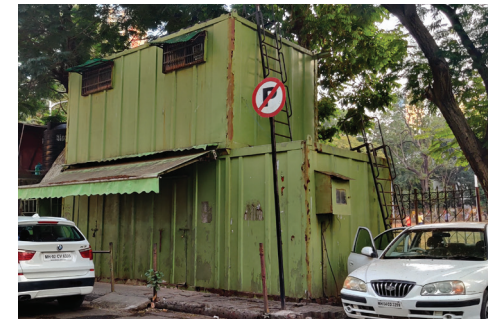
Existing structures on footpath - BMC Chowky

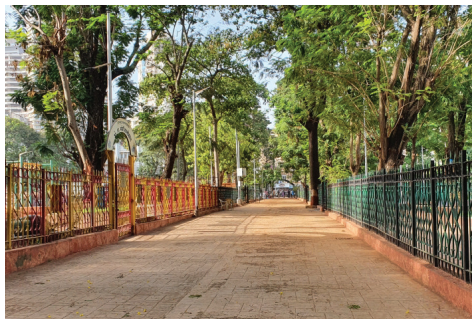
Internal fences cresting visual and physical barrier

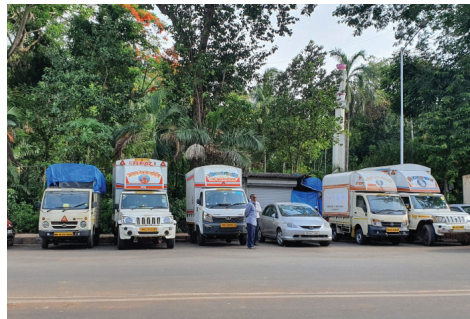
Parking along front periphery of Maidan, August Kranti Road

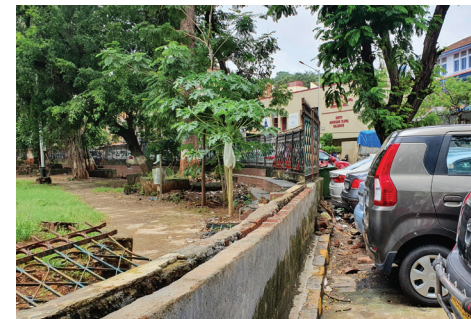
External fences in dilapidated condition

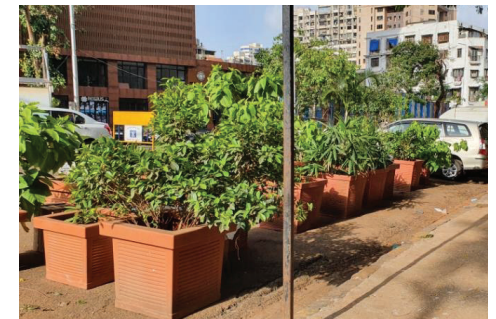
Encumbrances on footpath

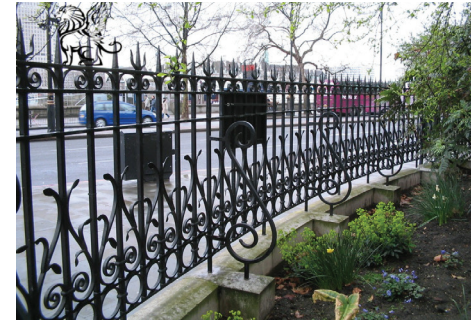
Restoration and reinstallation of gates and peripheral fencing

- Restoration of cast iron gates and fencing;
- Restoration of maidan back to its original setting by removal of fenced divisions;
- Creation of a permeable mud macadam pathway on the inner periphery of the maidan;
- Re-surfacing of central pathway with heritage basalt paving;
- Marking of Freedom Trail in inlay stone work/ paint;
- **Decluttering** of signage through consolidation and standardizing;
- **Footpath re-engineering** to provide uniform, levelled surfaces with at-grade crossing ramps and median refuge islands to provide universal accessibility;
- Safe streets - illuminating footpaths by adding dual arm to existing street lamps;
- Appropriate and **standardised street furniture** such as litter bins, benches and planters;
- Effective and **minimalistic bus shelter** and bus pole design to improve visibility to maidan;
- **Effective landscape** maintenance.

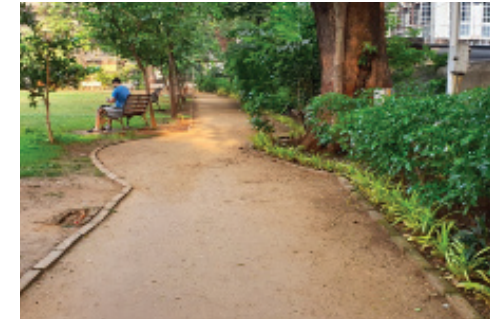
Creation of internal permeable mud macadam pathway

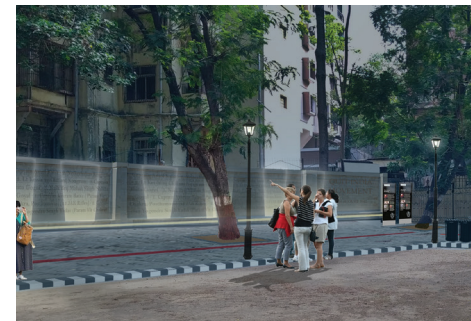
Creation of feature wall

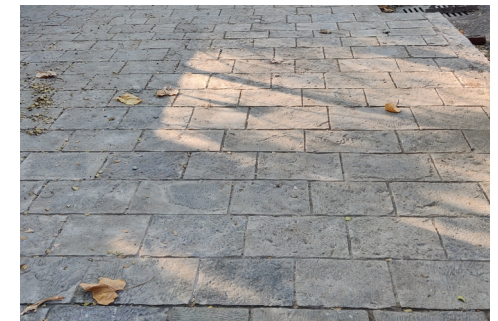
Heritage basalt stone paving

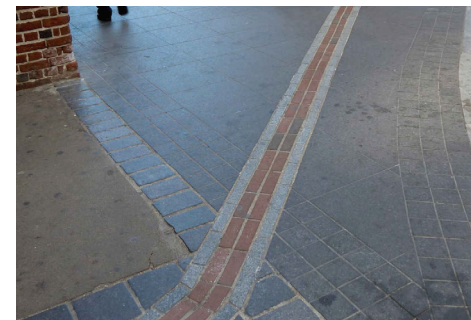
Freedom Trail marked in red on the paving

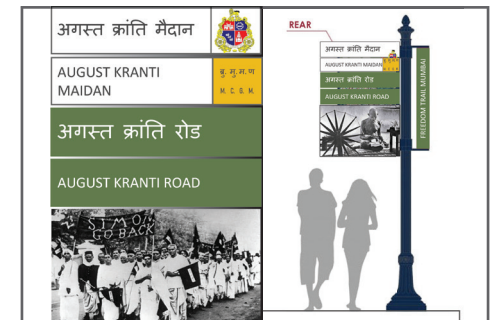
Standardised signage

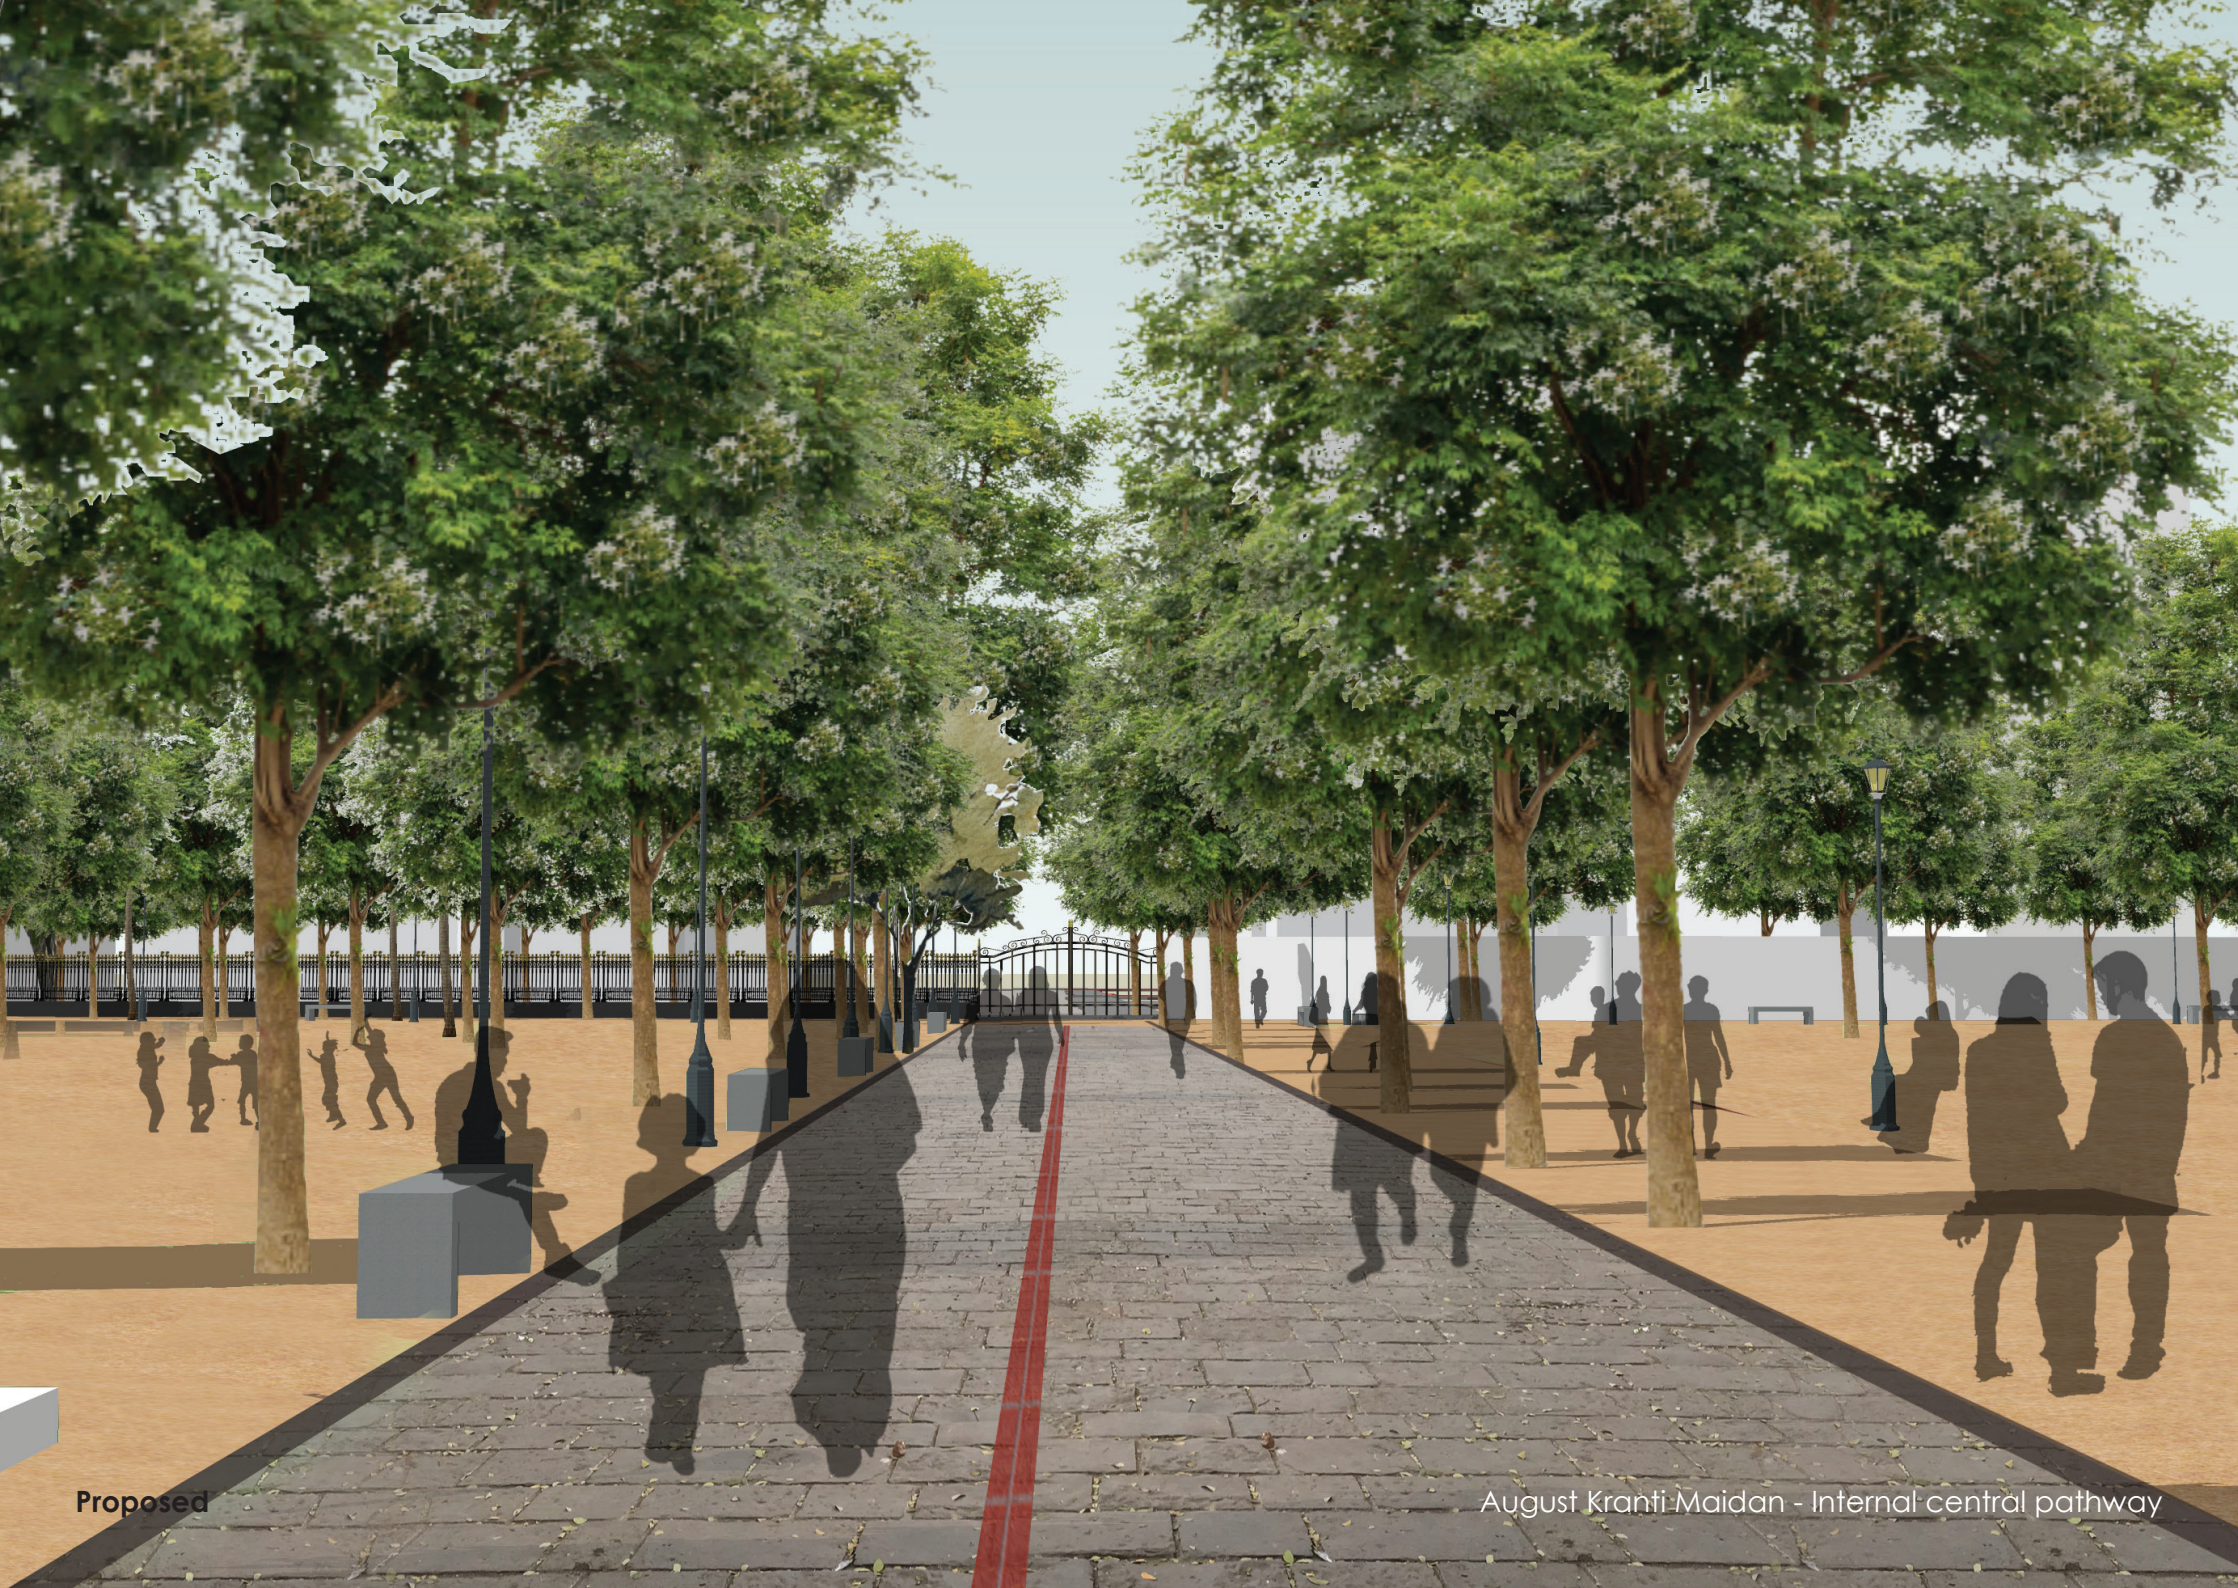
Proposed

August Kranti Maidan - Internal central pathway

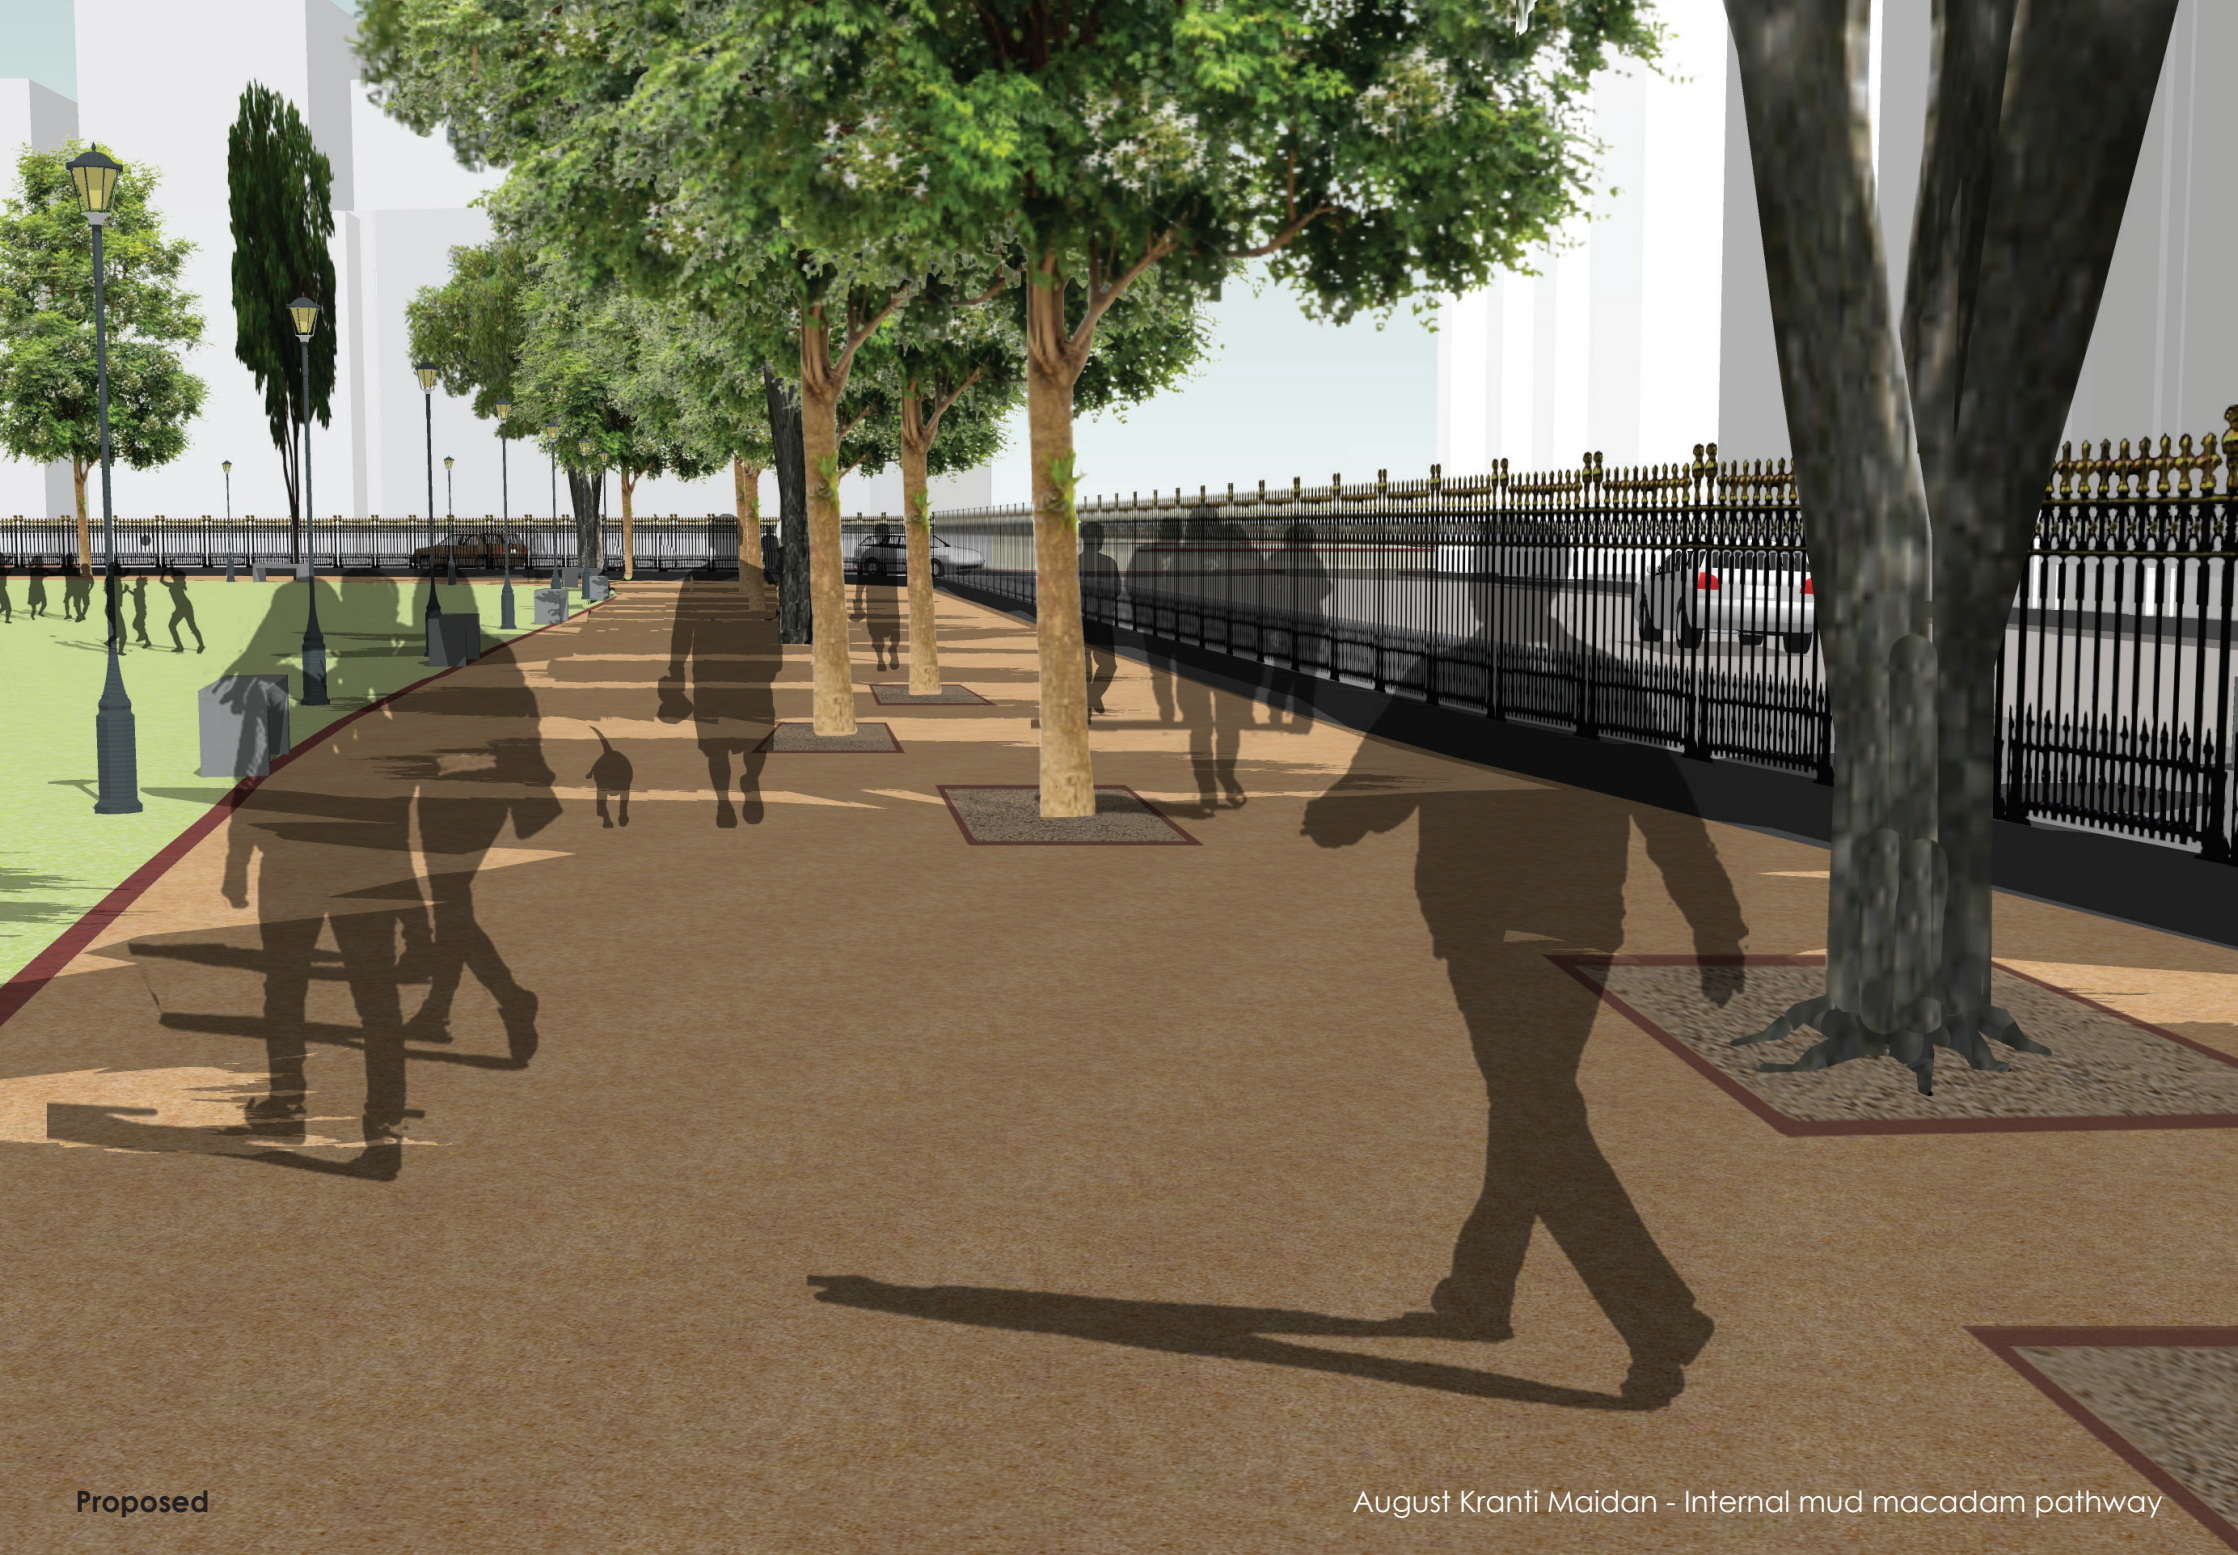
Proposed

August Kranti Maidan - Internal mud macadam pathway
